# *Blight Study*

Prepared for: **Village of Brewster**  
**50 Main Street**  
**Brewster, NY 10590**

**September 2014**

**Revised: February 2015**

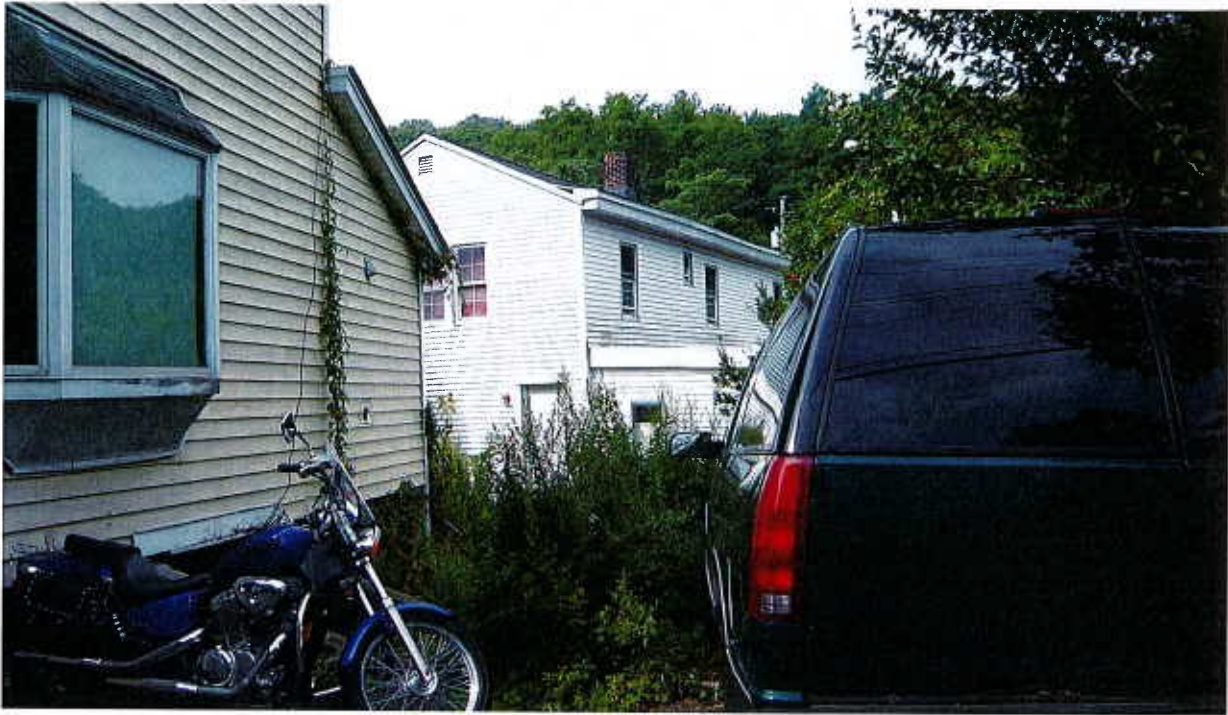
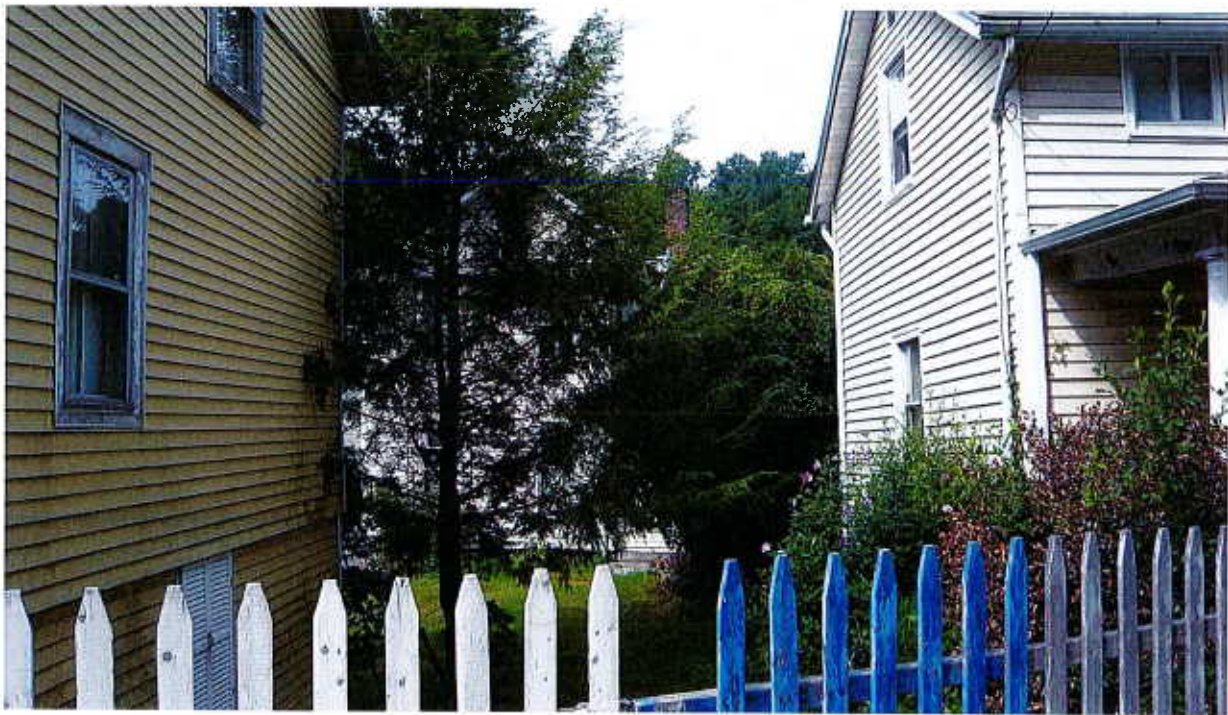
Overcrowding present among homes on Oak Street
